ERDC/CERL TR-01-57

Underground Storage Tank Location and Mapping of Former Landfills by Electromagnetic Surveys for the Delaware National Guard

August 2001

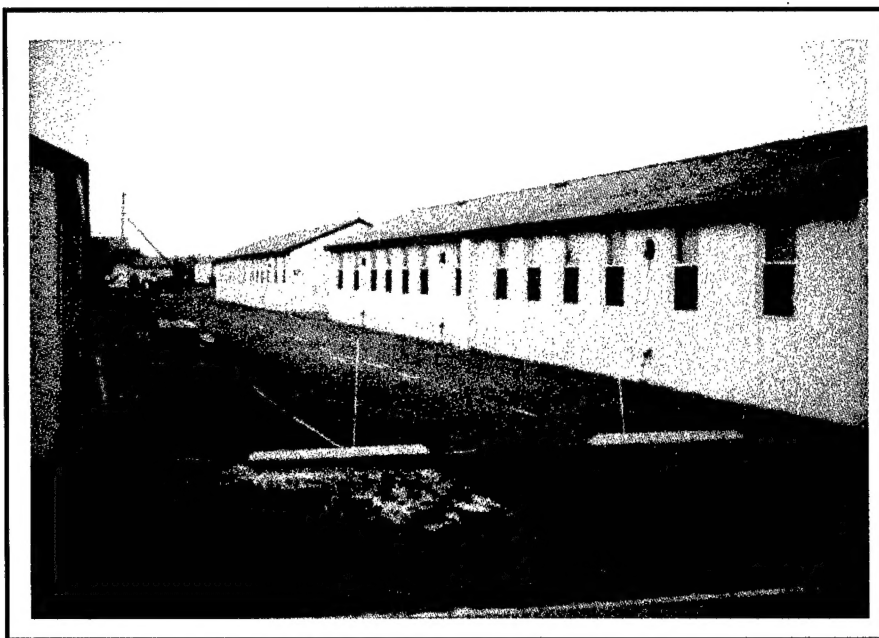
Figure 1. Tape measure placement for electromagnetic survey of area between rows of barracks, Bethany Beach, Delaware National Guard Training Base.

If a 5-ft grid is used, reasonably accurate positioning can be accomplished by placing tape measures 10 ft apart and by walking along the tape, taking a data point every 5 ft for one line of data points, then by walking in the middle between two tapes and reading the numbers on one of the two tapes for the intermediate data points. This is easy to accomplish for open, nonvegetated areas. Heavy vegetation makes it more difficult to set up the survey area and to accurately position the instrument for readings. Figure 1 shows a survey location set up between rows of barracks at Bethany Beach National Guard Training Base. The GEM-300 has a feature that allows it to take data at timed intervals. Thus a survey conducted at a walking pace can rapidly cover a relatively large area. (The operator does not need to stop at fixed locations to take data with the GEM-1.) The analysis software assumes a constant pace to locate the data points, so this technique is best suited for surveying nonobstructed areas.

These surveys were conducted as shown in Figure 1, by laying a short tape measure at both the south end and north end of each search area with the ends coincident with the building corners or the end of the survey area. Two long tape measures were then placed lengthwise at the 10- and 20-ft points on the short tapes. Data was taken on a 5-ft grid using the long tapes starting at with the first line at 5 ft from the building and completing the fifth line of data at 25 ft (5 ft from the neighboring building). Data was not taken at zero or 30 ft (at the building wall surface) because high readings caused by metal objects (bunk beds, refrigerators, and air-conditioners) inside or near the buildings would tend to mask any information from subsurface objects. Some building effects are still visible at 5 ft from the buildings.

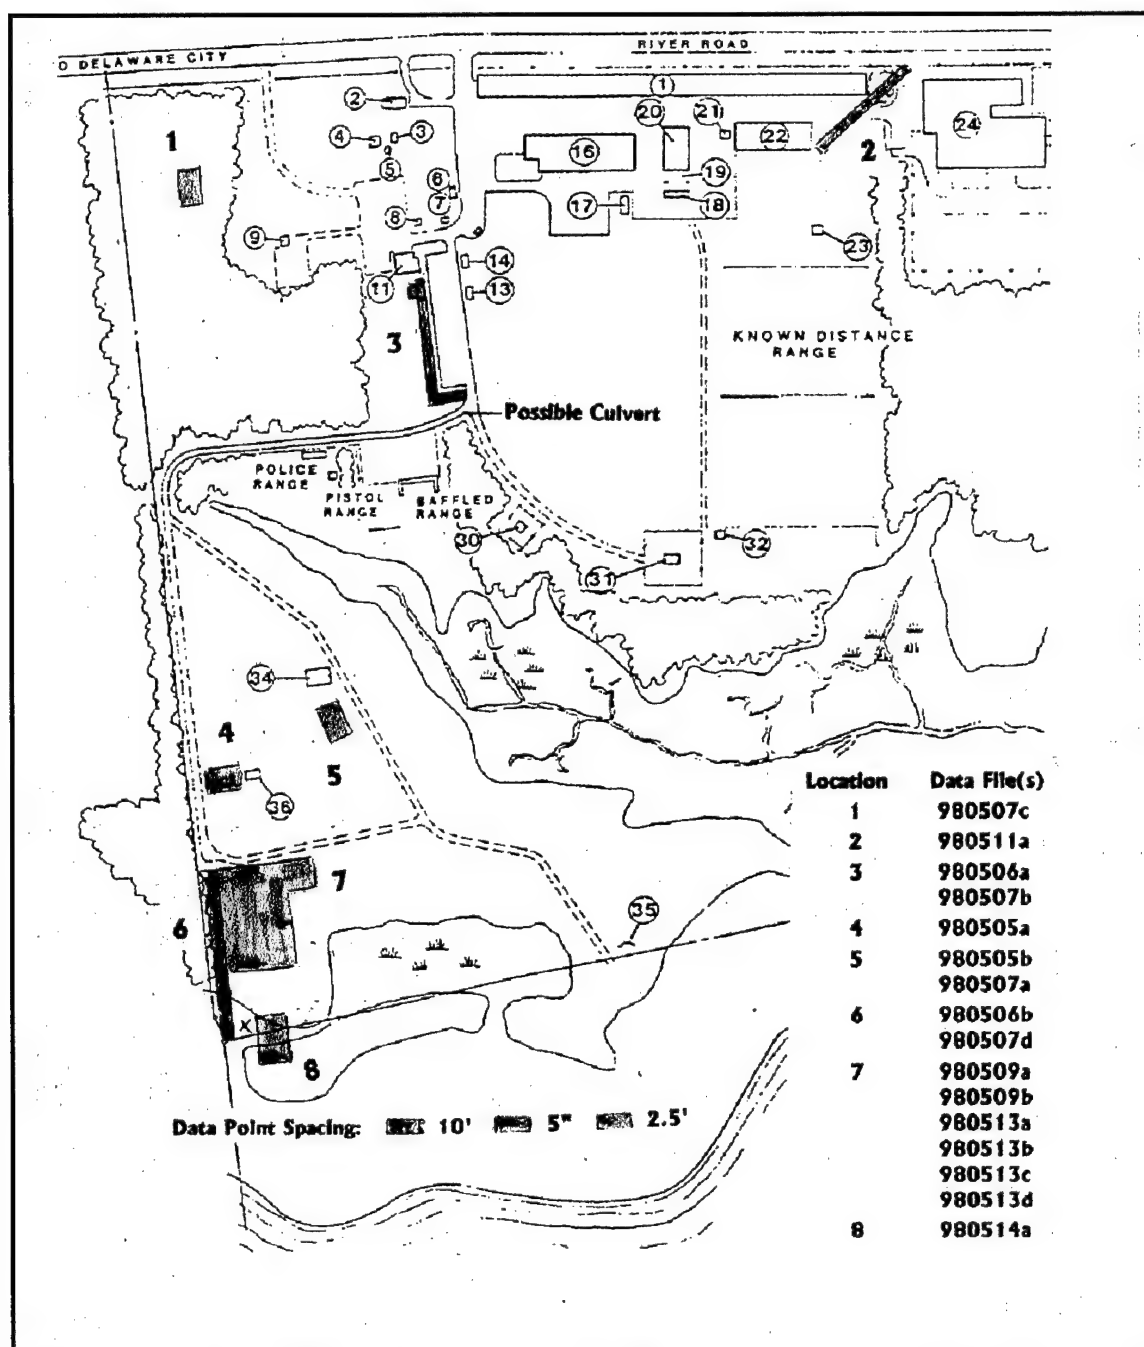
Figure 2 shows a map of part of the facility that identifies the areas surveyed in this part of the study. Note that, in this illustration, orientations are not exact and sizes were not scaled. The areas are:

1. An historic latrine with the building no longer present. This survey was conducted to identify possible underground storage tanks in the immediate area of the facility.

Figure 2. Locations of electromagnetic surveys conducted at the New Castle, Delaware Rifle Range, Delaware National Guard.

2. A diagonal path approximating a proposed sewer line exiting the base. This survey was conducted to identify possible conflicting metallic underground structures or to document their absence.
3. An area near a former building. One underground fuel storage tank had been removed from this area.
4. The open area by ammunition storage building #36 for possible buried barrels.
5. The open area by the ammunition igloo #34 for possible buried barrels.

6. (also 7 and 8) These are all parts of one area (identified as the tower area) to be searched for buried metallic structures. The goal was to survey the whole area, but portions were too densely covered with vegetation to allow traversing of the area. Significant quantities of surface metal items were also present in some areas.

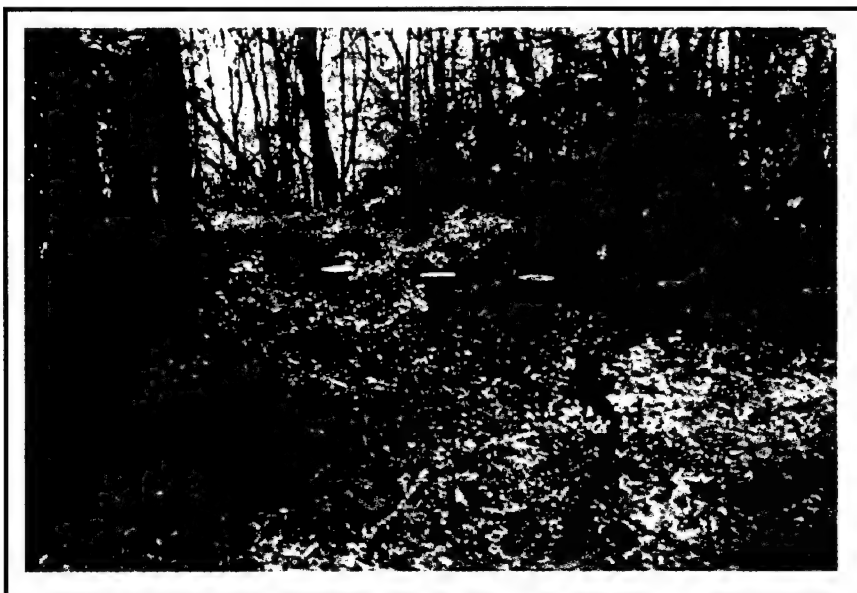
Location 1 on Figure 2 is a former latrine site probably dating from WWI. It is located in an area of forest with considerable underbrush in the immediate area (Figure 3). The building is gone except for the concrete floor and 12 stool fixtures. Nine, approximately 6-in. diameter metallic cylindrical and 1-in. pipe structures (4-5 ft total length) and a rusted out sheet metal structure (probably the urinal) were in the immediate area. These were placed near the stools during the surveys. A 50 X 75-ft area surrounding and including the floor was surveyed on 7 May 1998, to locate possible underground storage tank and/or septic tank fixtures related to the latrine structure. The results of this survey are given in Figure 4 (3200 Hz, in-phase data). The line of the stools is centered on the horizontal 30-ft line. The other target (between 40-50 horizontal and vertical is located where the urinal sheet metal had been found and may indicate an additional near surface, relatively small metal object in that area. No obvious tank-shaped structures were found in the survey area

Figure 3. Location 1, former latrine site, New Castle Delaware National Guard Rifle Range.

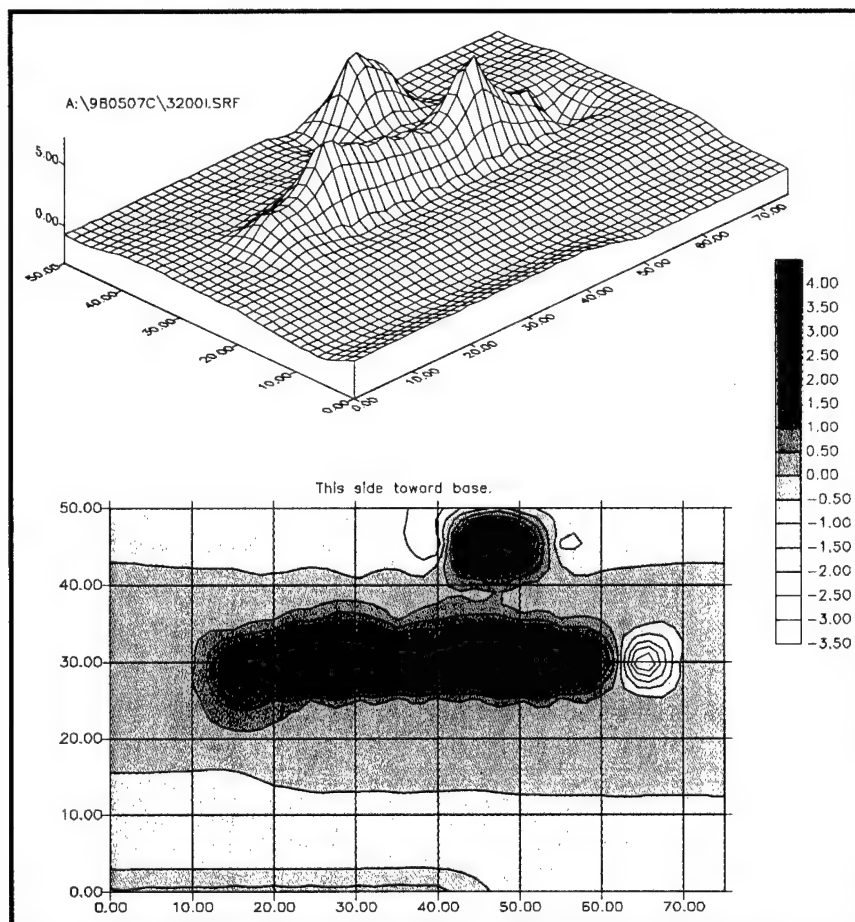
Figure 4. Electromagnetic survey results, Location 1, former latrine building site, 3200 Hz, in-phase data.

1. *Location 1, Historic Latrine.* No obvious tank-shaped structures were found in the survey area.
2. *Location 2, Proposed Sewer Line.* No subsurface objects or structures were identified.

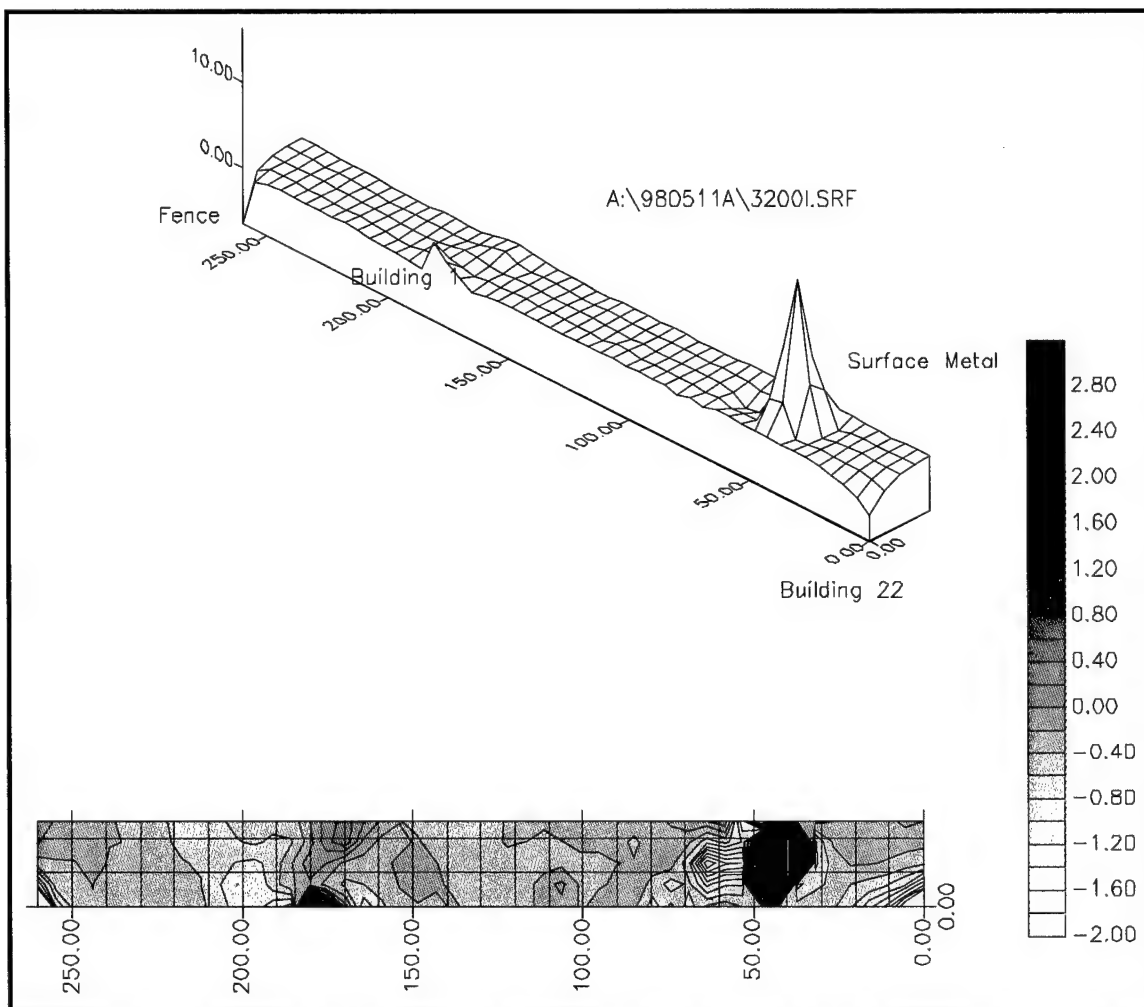
Location 2 is an area identified for future installation of a sewer line. It was surveyed 11 May 1998. The survey was conducted within 10 ft of Buildings 1 and 22 and the perimeter fence. The plot of the survey data (Figure 5) shows the effects of each of these. Some surface metal objects were in the area surveyed. These consisted of a small portion of metallic landing mat material and a broken box of small metal plates scattered near the portion of landing mat. No subsurface objects or structures were identified.

Figure 5. Electromagnetic Survey Results, Location 2, Proposed Sewer Line, 3200 Hz, in-phase data.

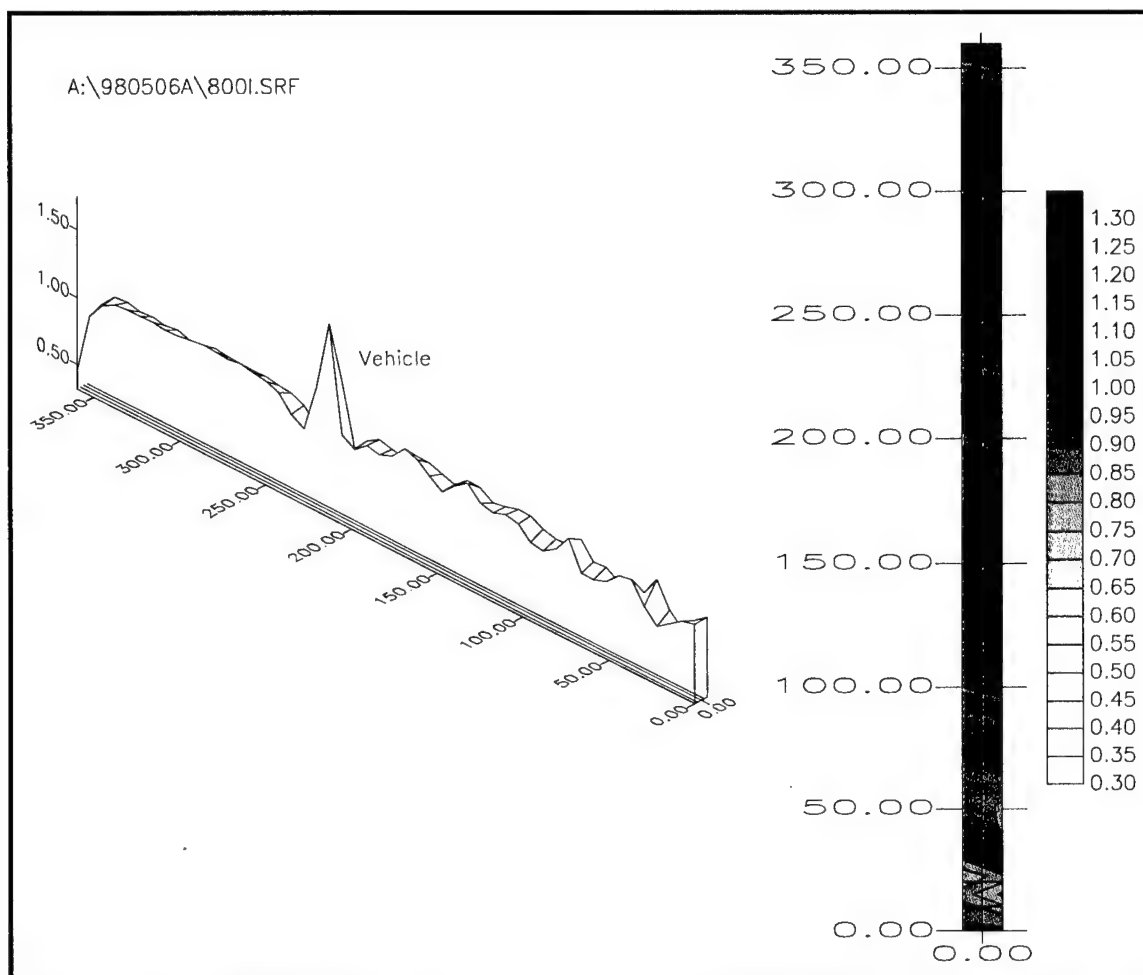
Figure 6 shows partial results of this survey. A buried object was found near the manhole cover close to Building 11 and a more detailed survey (with 2.5-ft data point spacing) was conducted there (see Figure 7). Note that the axis dimensions are a factor of 10 more than the actual distances due to fact that the macro used for the automated spreadsheet calculations will not accept decimal numbers. The results of this more detailed survey indicated that the underground structure extended to a point near the manhole. It was concluded that the underground object was probably the septic tank for Building 11 (Figure 8). The high reading at about 225 ft in Figure 6 coincided with a vehicle parked near the edge of the slab. An apparent covered culvert was found where the road turns to go past the target ranges. This location is identified in Figure 2.

Figure 6. Electromagnetic survey location 3, 3200 Hz, in phase measurement.

3. *Location 3, Near Slab Used for Vehicle Parking.* A buried object was found near the manhole cover close to Building 11, probably the septic tank for this Building. An apparent covered culvert was found where the road turns to go past the target ranges.

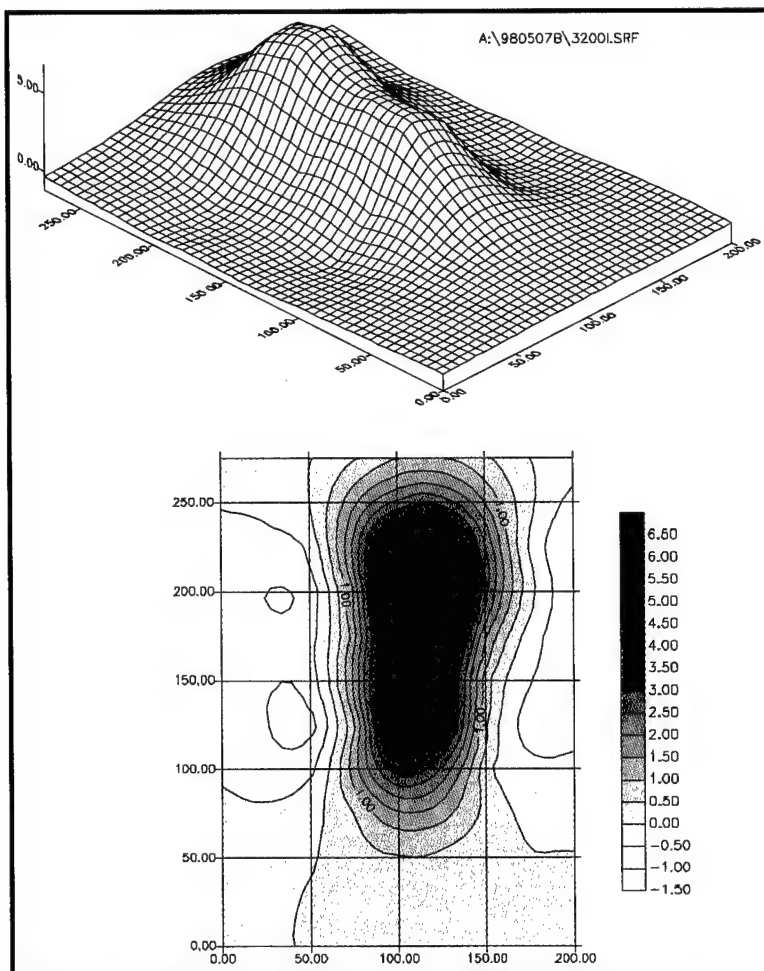
Figure 7. Suspected underground tank near building 11 (2.5-ft data point spacing).

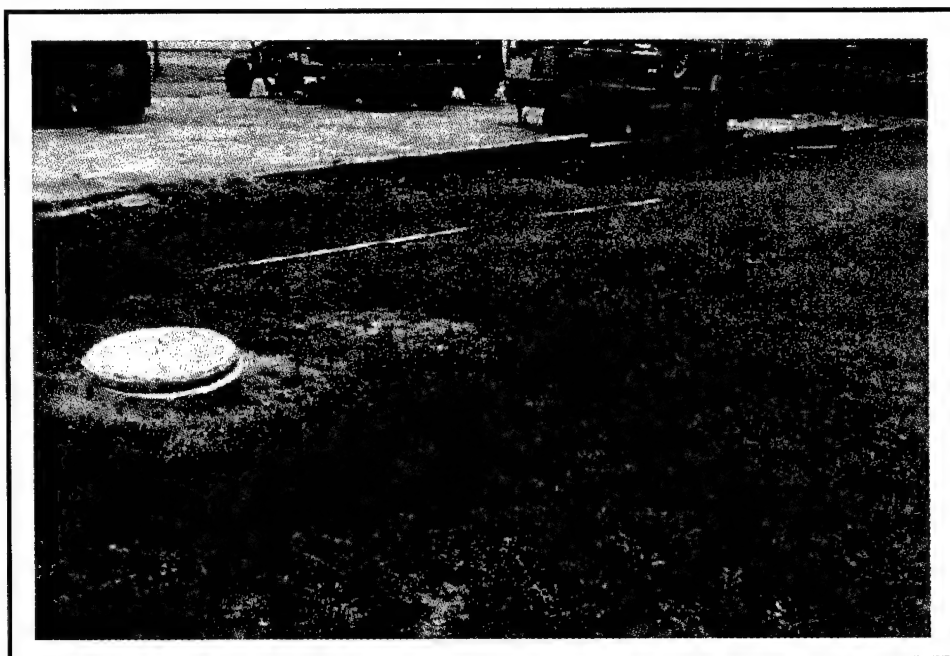
Figure 8. Apparent location of septic tank location for Building 11.

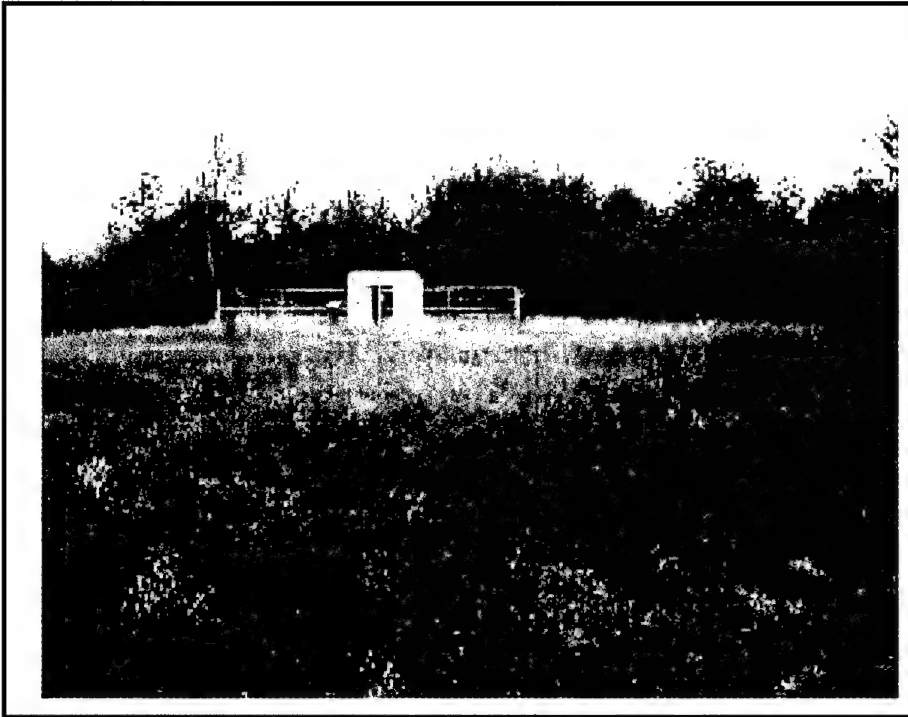
Location 4 is the generally open area between the fence surrounding the ammo storage building #36 and the perimeter road (Figure 9). A 150 X 70-ft area was surveyed as sketched in Figure 10. No significant targets were discovered in this area. Figure 11 shows the results of this survey. The low level data value at the corner (0, 90) is due to instrument startup drift. The linear structure indicated by the data at (20, 0-120) is probably due to a small instrument instability. The variations in the data magnitudes here are relatively small when compared to other readings and do not indicate subsurface structures in this area. The drift effects could be filtered out with specialized data processing techniques if the surveys were being conducted for locating very small objects. The GPS reading at the corner labeled "Start" was 39 degrees 37.80 minutes north latitude and 75 degrees 36.52 west longitude.

Figure 9. Location 4 survey area, New Castle Rifle Range, Delaware.

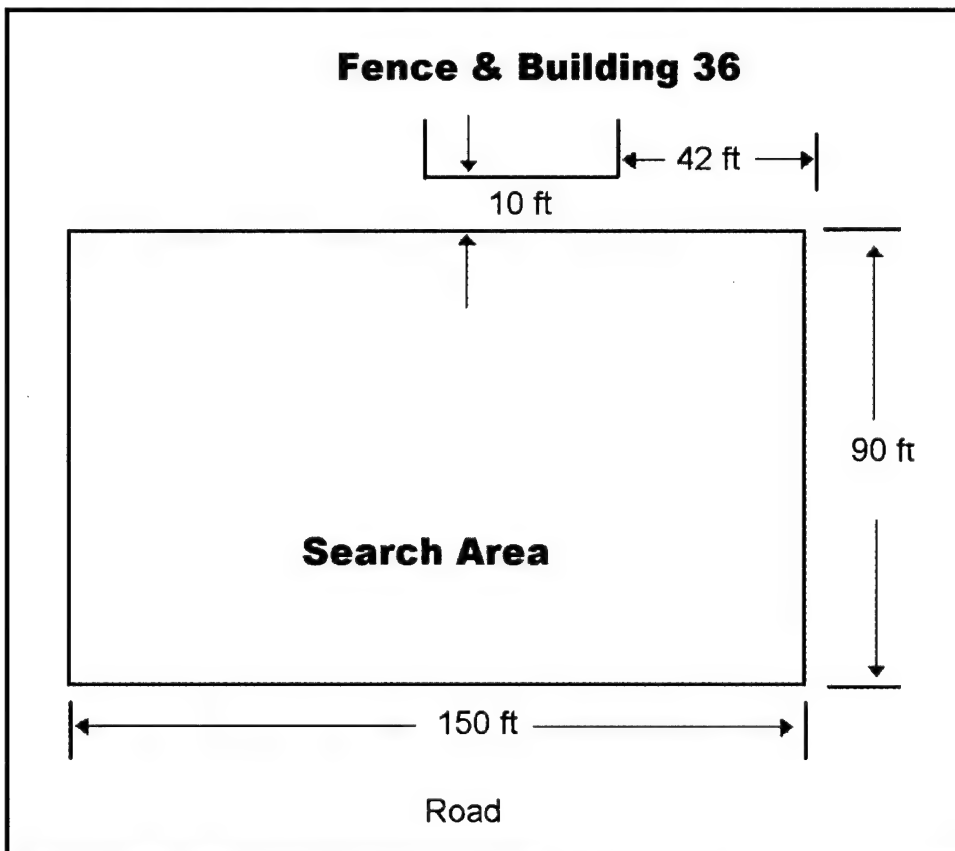
Figure 10. Orientation of location 4 search area.

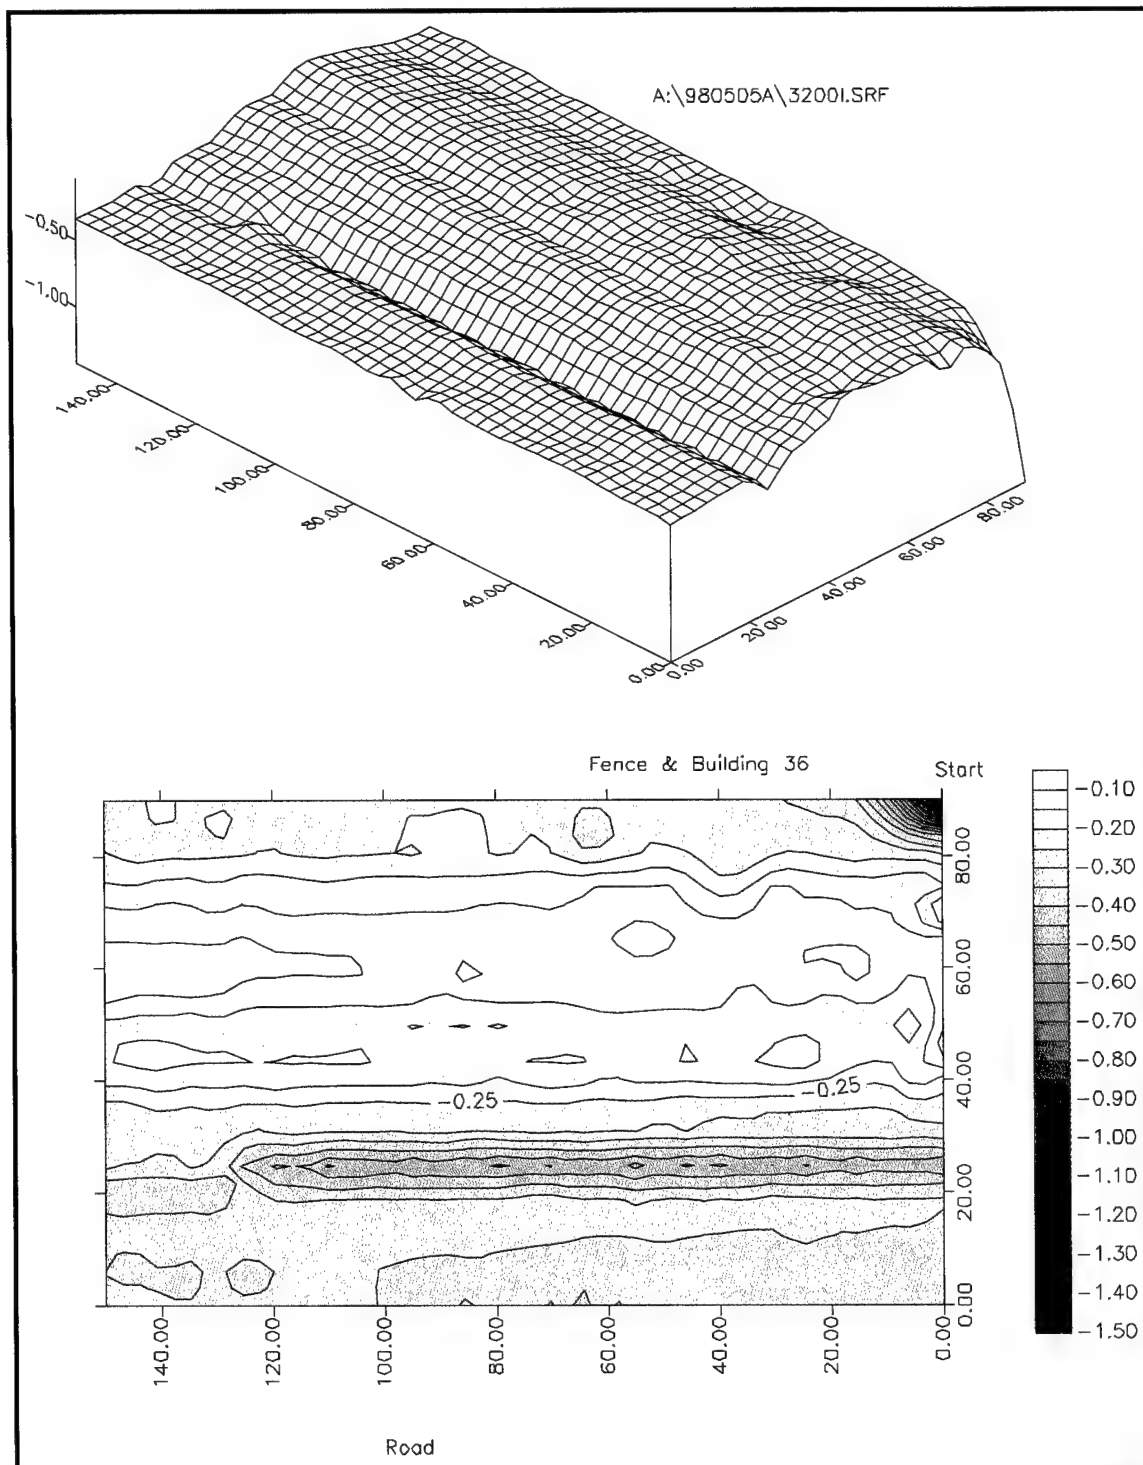
Figure 11. Electromagnetic survey results, 3200 Hz, in-phase, near Building 36, Location 4.

4. *Location 4, Near Building 36.* No significant targets were discovered in this area.
5. *Location 5, Near Building 34.* No buried metallic objects were discovered in this area.

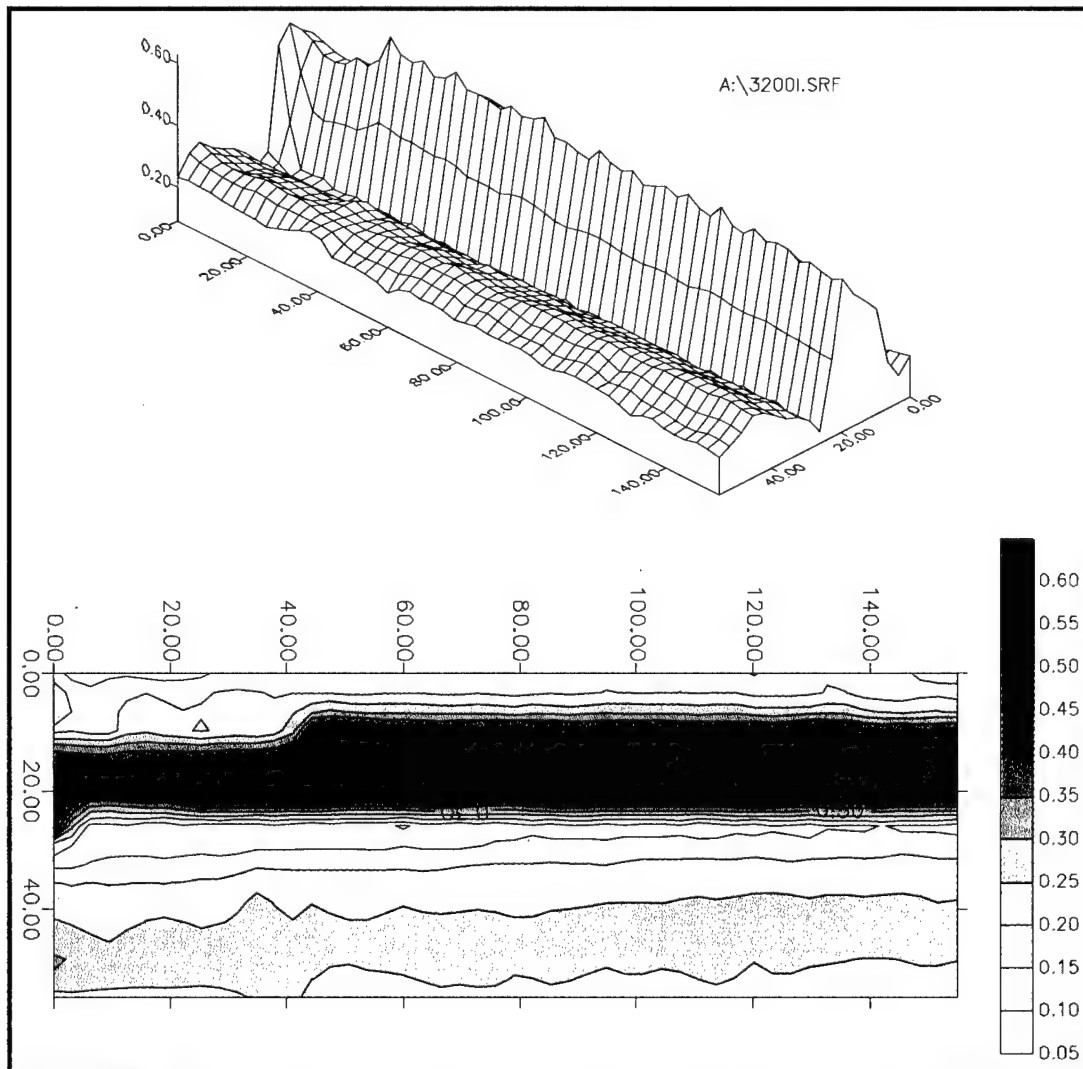
rate days, since the first day's data gathering was interrupted by rain. Figure 12 shows the results of this survey. No buried metallic objects were discovered in this area. The discontinuity in the data results from instrument drift resulting from taking the data on 2 separate days and could be filtered out if desired. The color scale shows the relatively small total variation in readings as compared to possible variations due to targets of significant size.

Figure 12. Electromagnetic survey results from location 5, 3200 Hz, in-phase data.

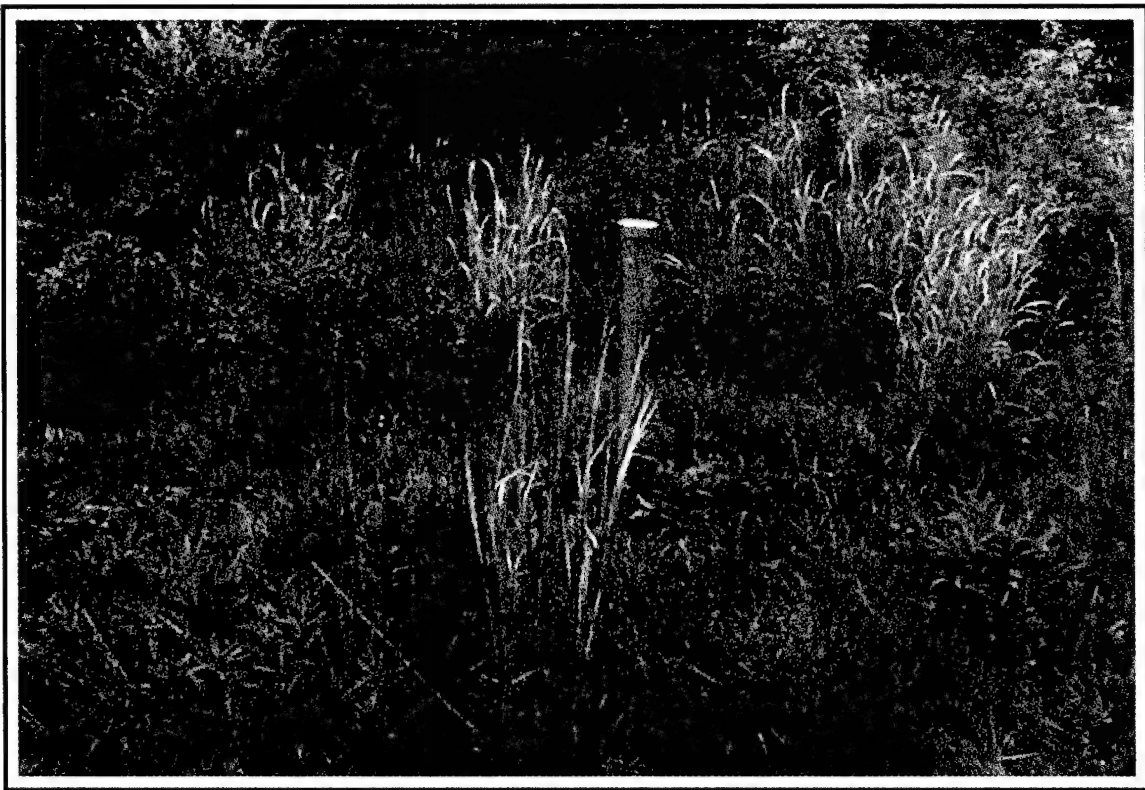
The results of the surveys conducted in this area are plotted as Locations 6, 7a, 7b, and 8. Figure 13 shows a photograph of the test well located along the road side of survey Location 6 and Figure 14 shows a photograph of the watch tower area from the adjacent road.

Figure 13. Test well on road end of survey location 6, New Castle Rifle Range, Delaware.

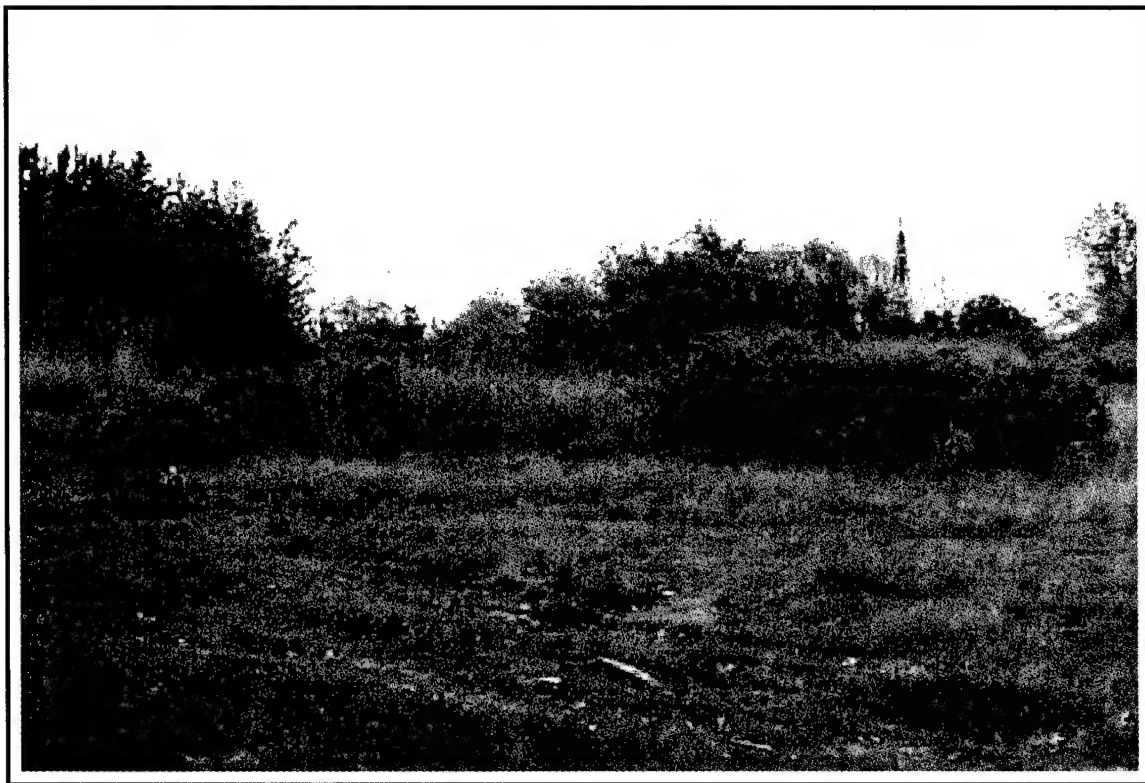
Figure 14. Watch Tower area, New Castle Rifle Range, Delaware.

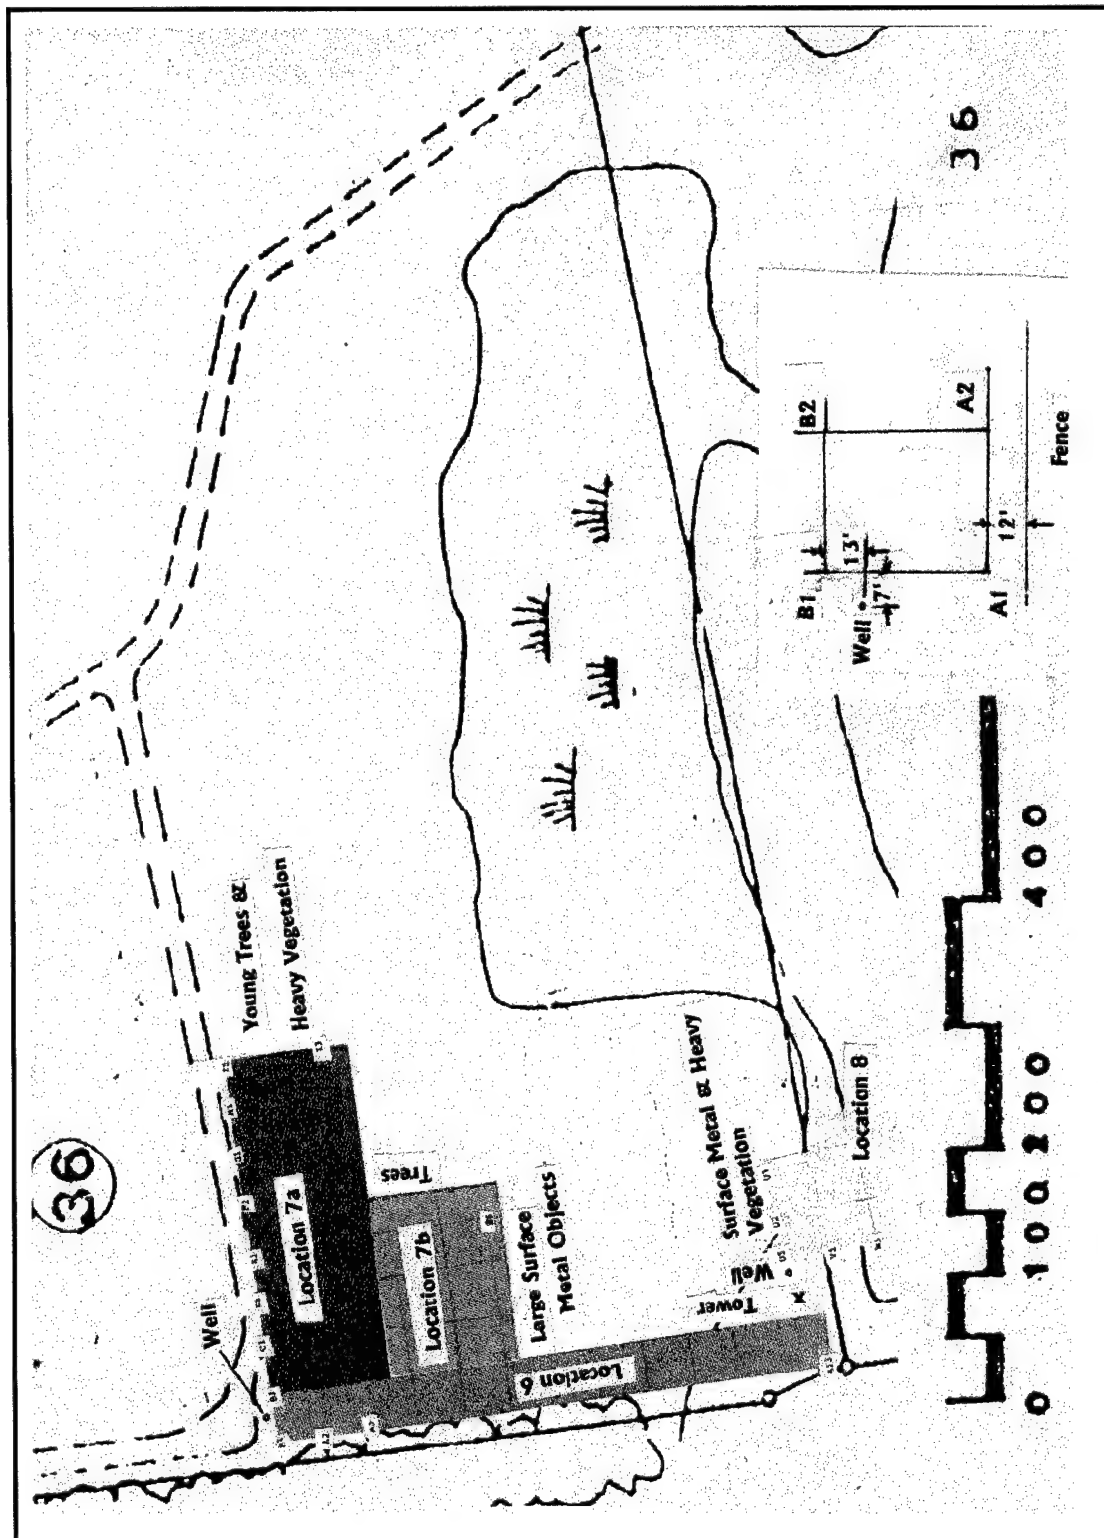
Initial plans were to collect data from the total area bounded by the installation borders and the road. Since this is a relatively large area and the objects to be located are relatively large, the survey for the area was begun by laying measuring tapes every 10 ft from the road on the base side of the area to the creek by the watchtower. The first tape was placed 12 ft from the border fence. Data points were taken every 10 ft. It was determined that this technique was impractical for surveying the total area due to the amount of vegetation and the amount of surface metal found. The area labeled Location 6 was surveyed in this way. To ensure location of objects as small as a 55-gal drum, the remainder of the accessible area was surveyed on a 5-ft grid. The area to be searched was laid out in 40-ft squares with wooden stakes placed at the corners. The stakes were labeled starting with A1 near where the road turns away from the facility border fence to A13 next to the creek near the watchtower and from A1 – I1 along the road. The data plots are presented to facilitate conversion to this grid. Location 8 was near the watchtower and not directly adjacent to any of the other search areas. The grid for Location 8 was labeled from U1 – W1 to U3 – W3. These areas are shown in greater detail in Figure 15.

Figure 15. Detail of Watchtower survey area.

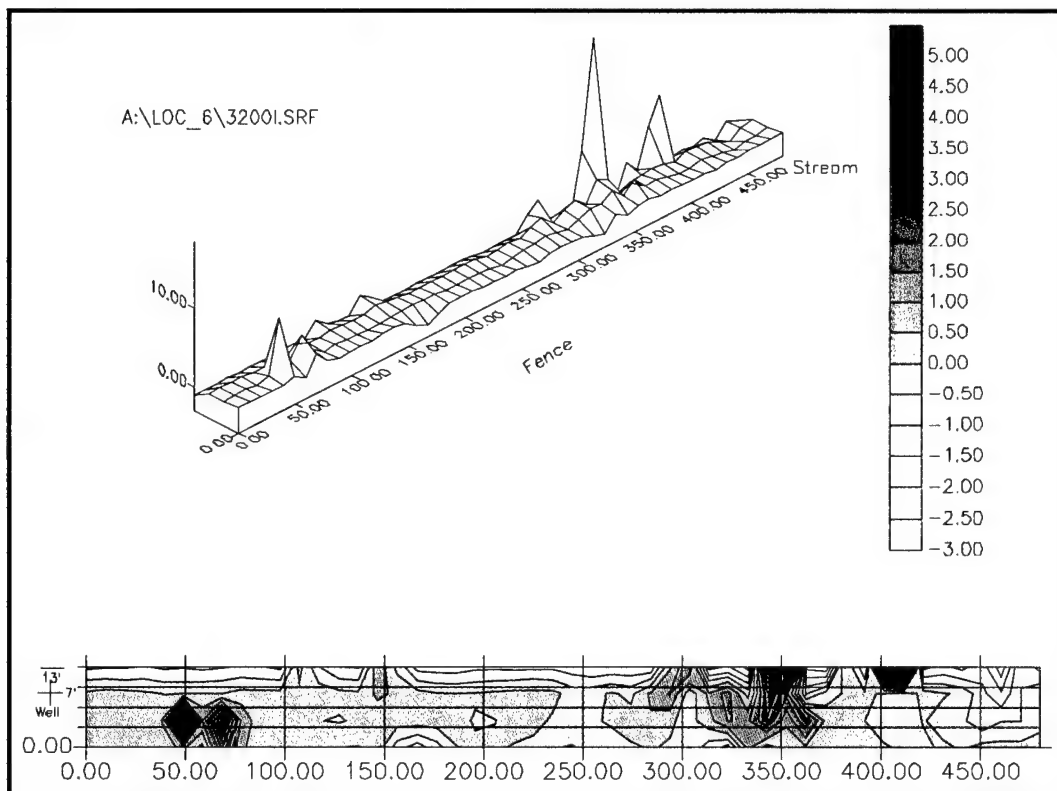
Location 6 is a part of the watch tower area as shown in Figures 2 and 15. This data was taken on 10-ft centers with the tape measures placed 10 ft apart and aligned parallel to (approximately 12–13 ft distant from) the facility border fence. Due to the dense brush and forest conditions, it was not possible to continue conducting the survey in this way. In addition, 10-ft point spacing may result in missing small metal objects located in the center of the 10 ft squares delineated by the data points. Thus, 5-ft data point spacing was used for the remainder of the surveys in this area. Possible subsurface metallic objects at the 50-ft marker in location 6 (Figure 16) and between 300–400 ft markers in location 6 strongly indicate typical landfill conditions. The high peak reading at about 350 ft coincided with a surface location of metallic landing mat material. Significant other surface metal was present in this area. Figure 16 shows the results of the survey of Location 6.

Figure 16. Electromagnetic survey results of location 6, 3200 in-phase data.

6. *Locations 6, 7, and 8, Watchtower Area.* In Location 6, possible subsurface metallic objects exist at the 50-ft marker in location 6 (cf. Figure 16). The area between the 300- and 400-ft markers in location 6 strongly indicates typical landfill conditions. The high peak reading at about 350 ft coincides with a surface location of metallic landing mat material. Significant other surface metal was present in this area

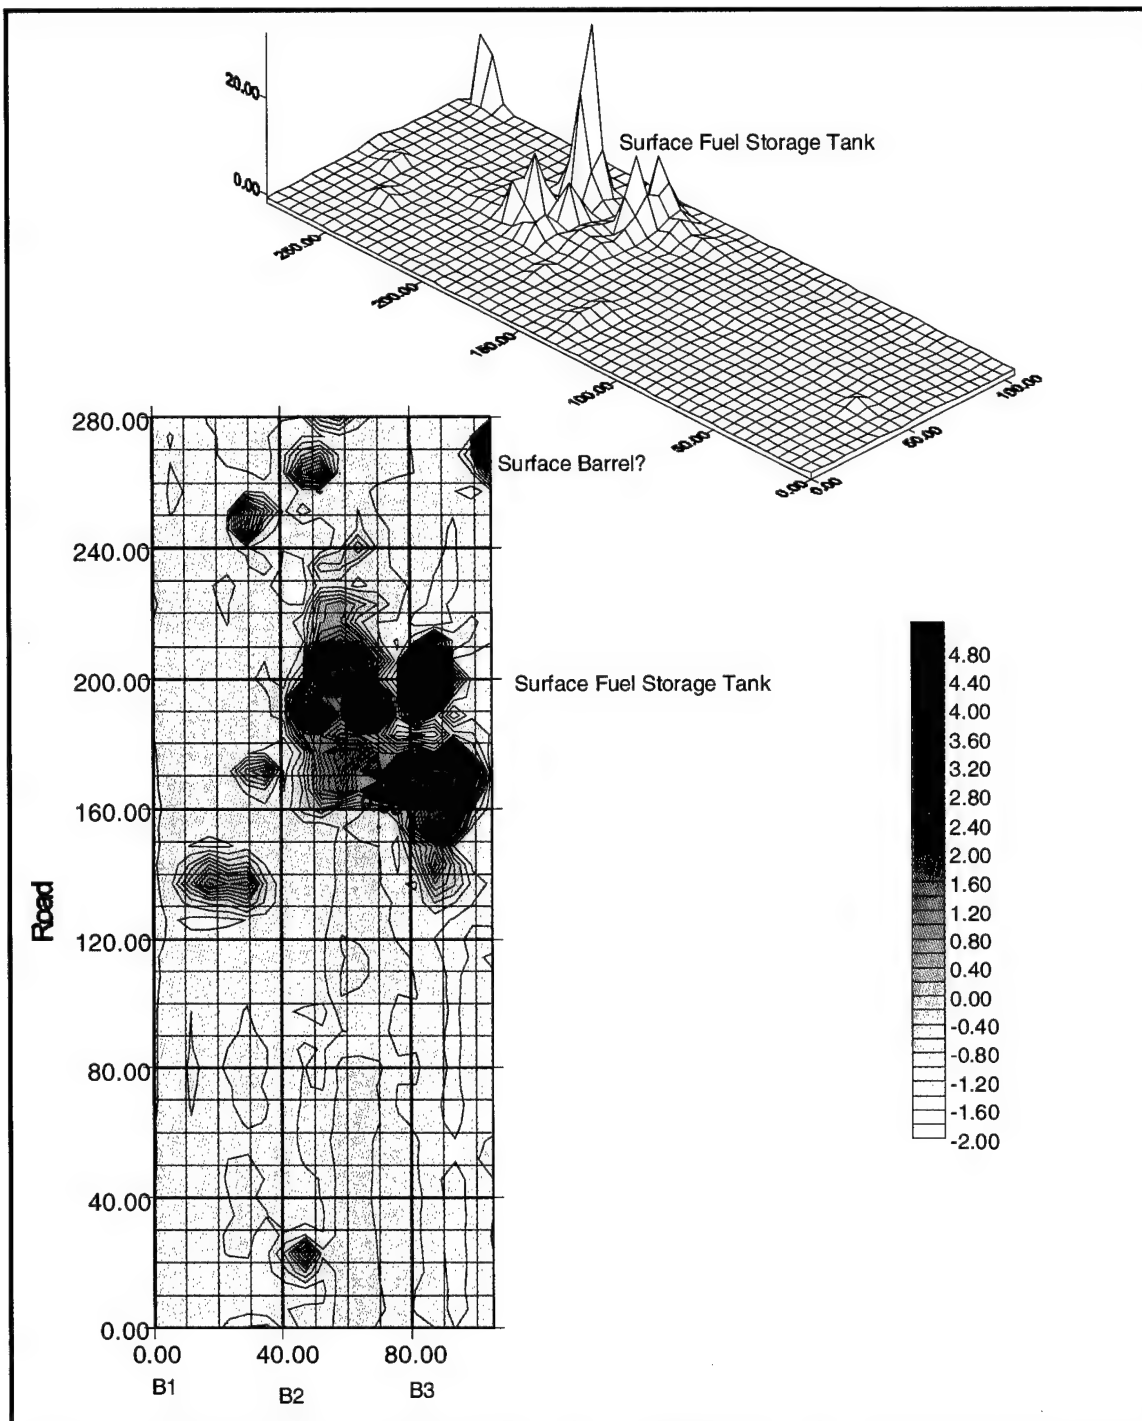
Location 7a is the area from B1, I1 to 25 ft past B3, I3 in the watch tower area as shown on Figures 2 and 15. The results of this survey are shown in Figure 17. Two empty barrels and an empty aboveground fuel storage tank were on the surface in or near this area. The tank was located near the G3 stake. The area near the tank appears to have a considerable amount of buried metal and may have been used as a landfill. It is recommended that the surface metal in this area be removed and the area be considered for resurveying. The item appearing at (40, 25) is a surface snow shovel. The open area from B1, E1 to B3, E3 seems to be relatively clean.

Figure 17. Electromagnetic survey results of location 7a, Watchtower area, New Castle Rifle Range, New Castle, DE, 3200 Hz, in-phase data.

Location 7a appears to have a considerable amount of buried metal and may have been used as a landfill. It is recommended that the surface metal in this area be removed and the area be considered for resurvey.

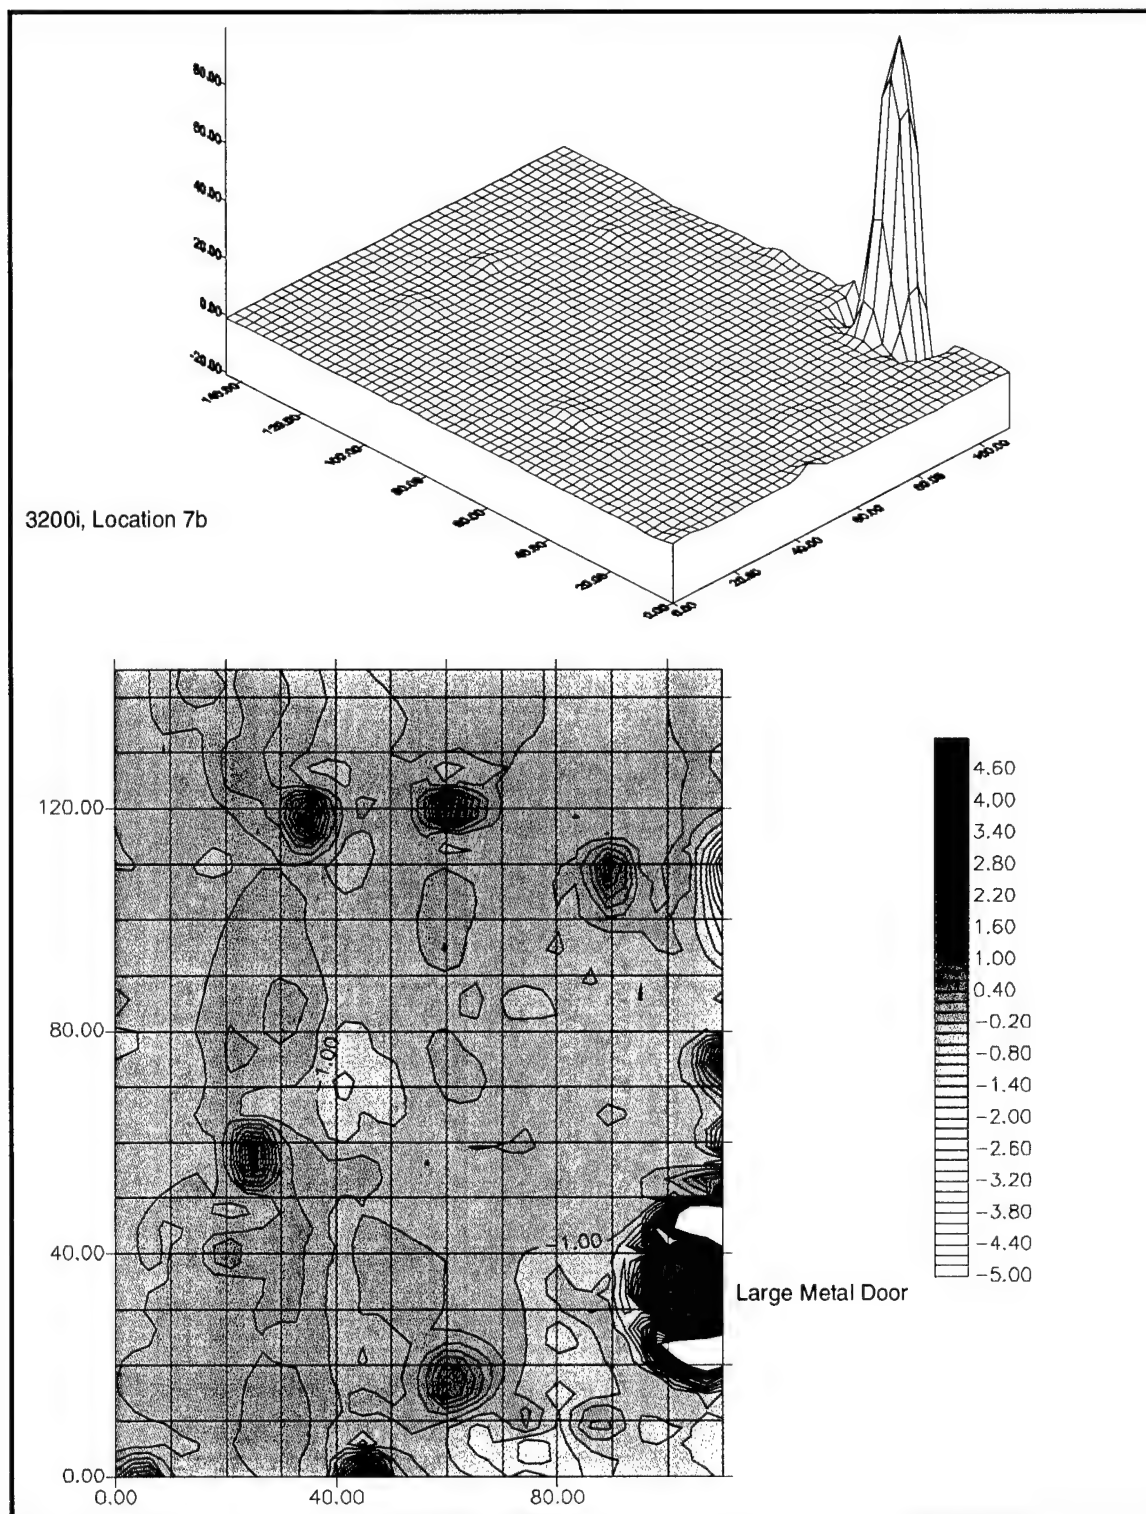
Location 7b is immediately adjacent to Location 7a, but the data rows are 145 ft in length rather than 280 ft as in Location 7a. The heavy stand of trees and brush made data gathering beyond 145 ft impossible. This area was relatively clean with the exception of a large metal door on the surface located at about (100, 30-40). The survey was not continued further in this direction because of other similar large surface metal structures and because of the dense brush beyond the surface metal. This area did not appear to have been used as landfill. The item at 45,0 did not appear on the adjacent Location 6 plot and is probably a small shallow buried metal item. The 3200 Hz, in-phase data are shown in Figure 18. Some of the surface metal in this area is shown in Figure 19.

Figure 18. Location 7b, Watchtower Area, 3200 Hz, in-phase data.
